Manhole Inspection Summary

Manhole # S21AA1003MH

Insp Date: **10/27/08 9:06 AM**

Location Address: **PARKDEN AVE** Cross Street: **OAKINGTON ST**

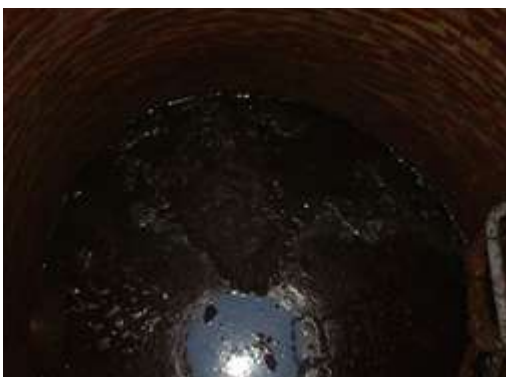
Top View

1st visit. Needs cleaning.

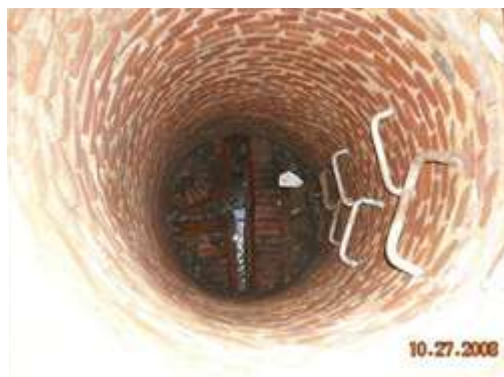
Top View

Corroded steps. Evidence of surcharge - Bench debris.

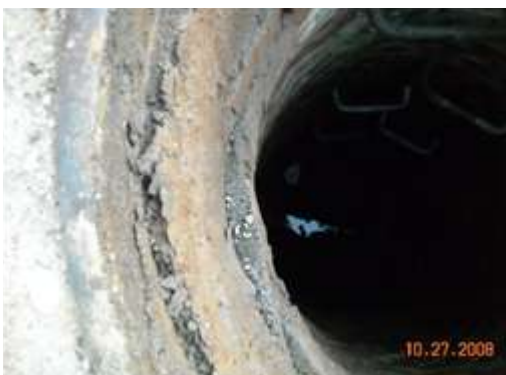
Defect

Frame leaks. Frame offset. Adjustment infiltration.

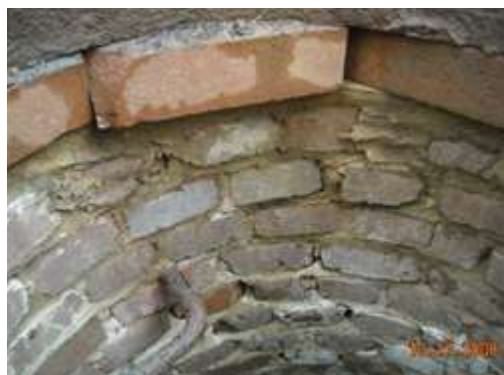
Defect

Frame leaks. Adjustment and Corbel deterioration and infiltration.

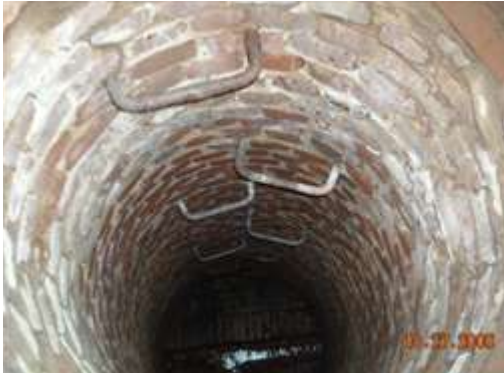
Defect

Adjustment, Corbel and Barrel infiltration.

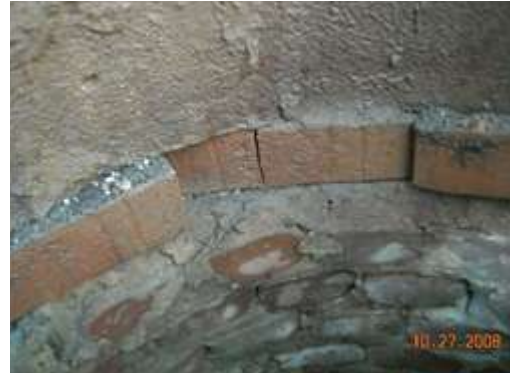
Defect

Frame leaks. Adjustment deterioration and infiltration. Corbel infiltration.

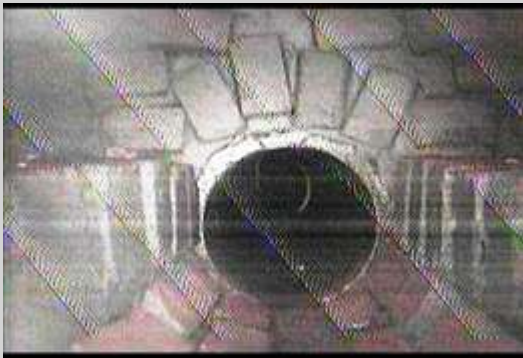
8 in. Circular Gravity Sewer Pipe Out @ 12 O'Clock

Barrel deterioration and infiltration. Channel deterioration.

Infiltration: **Evidence** Pipe Seal Cond: **Cracked**

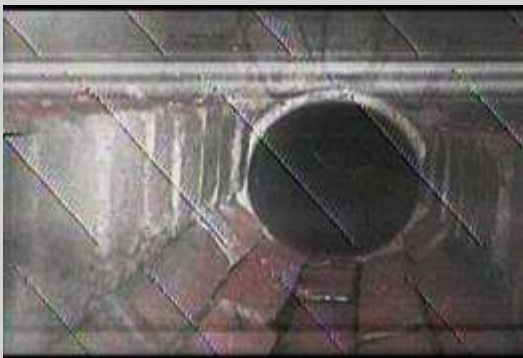
8 in. Circular Gravity Sewer Pipe In @ 6 O'Clock

Channel deterioration and infiltration.

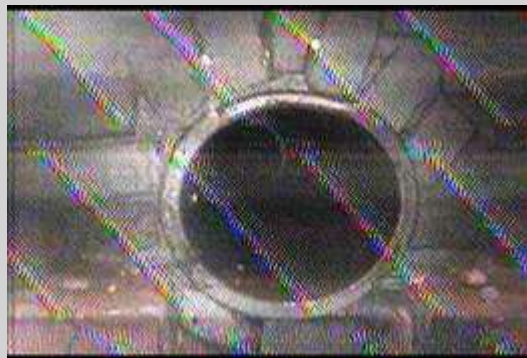
Pipe In @ 9 O'Clock

Pipe Seal Cond: **Cracked**
